VILLAGE OF SENECA

LASALLE COUNTY, ILLINOIS

FLOODPLAIN MANAGEMENT

RECONNAISSANCE STUDY

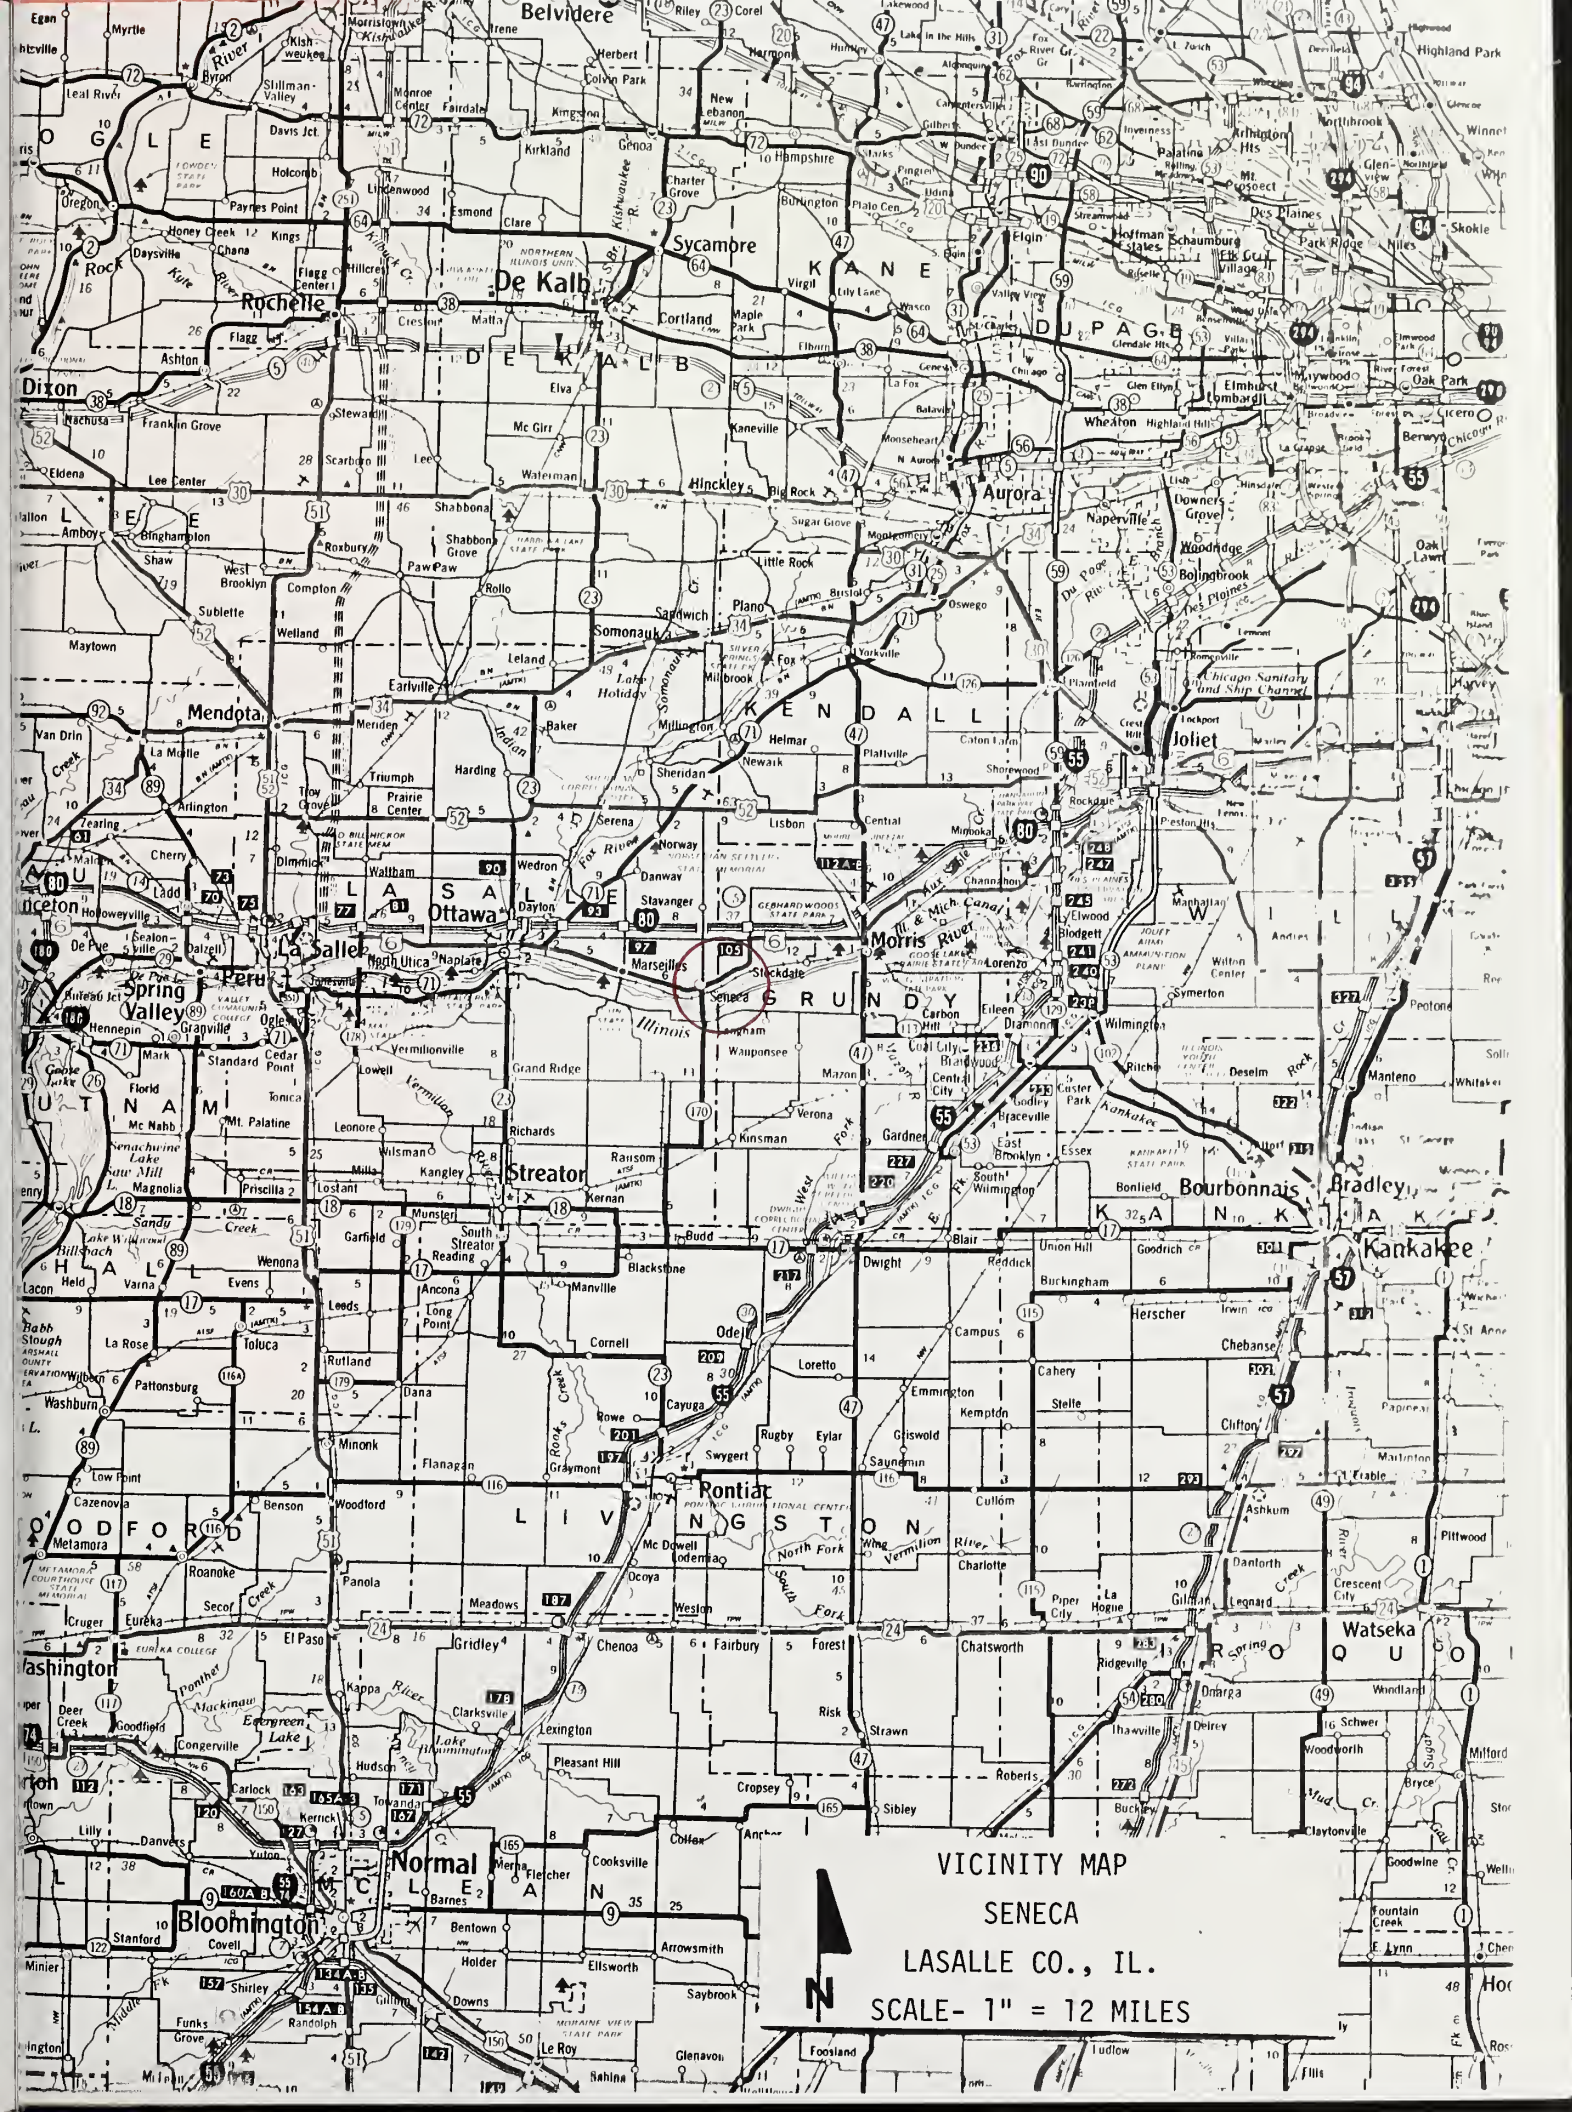
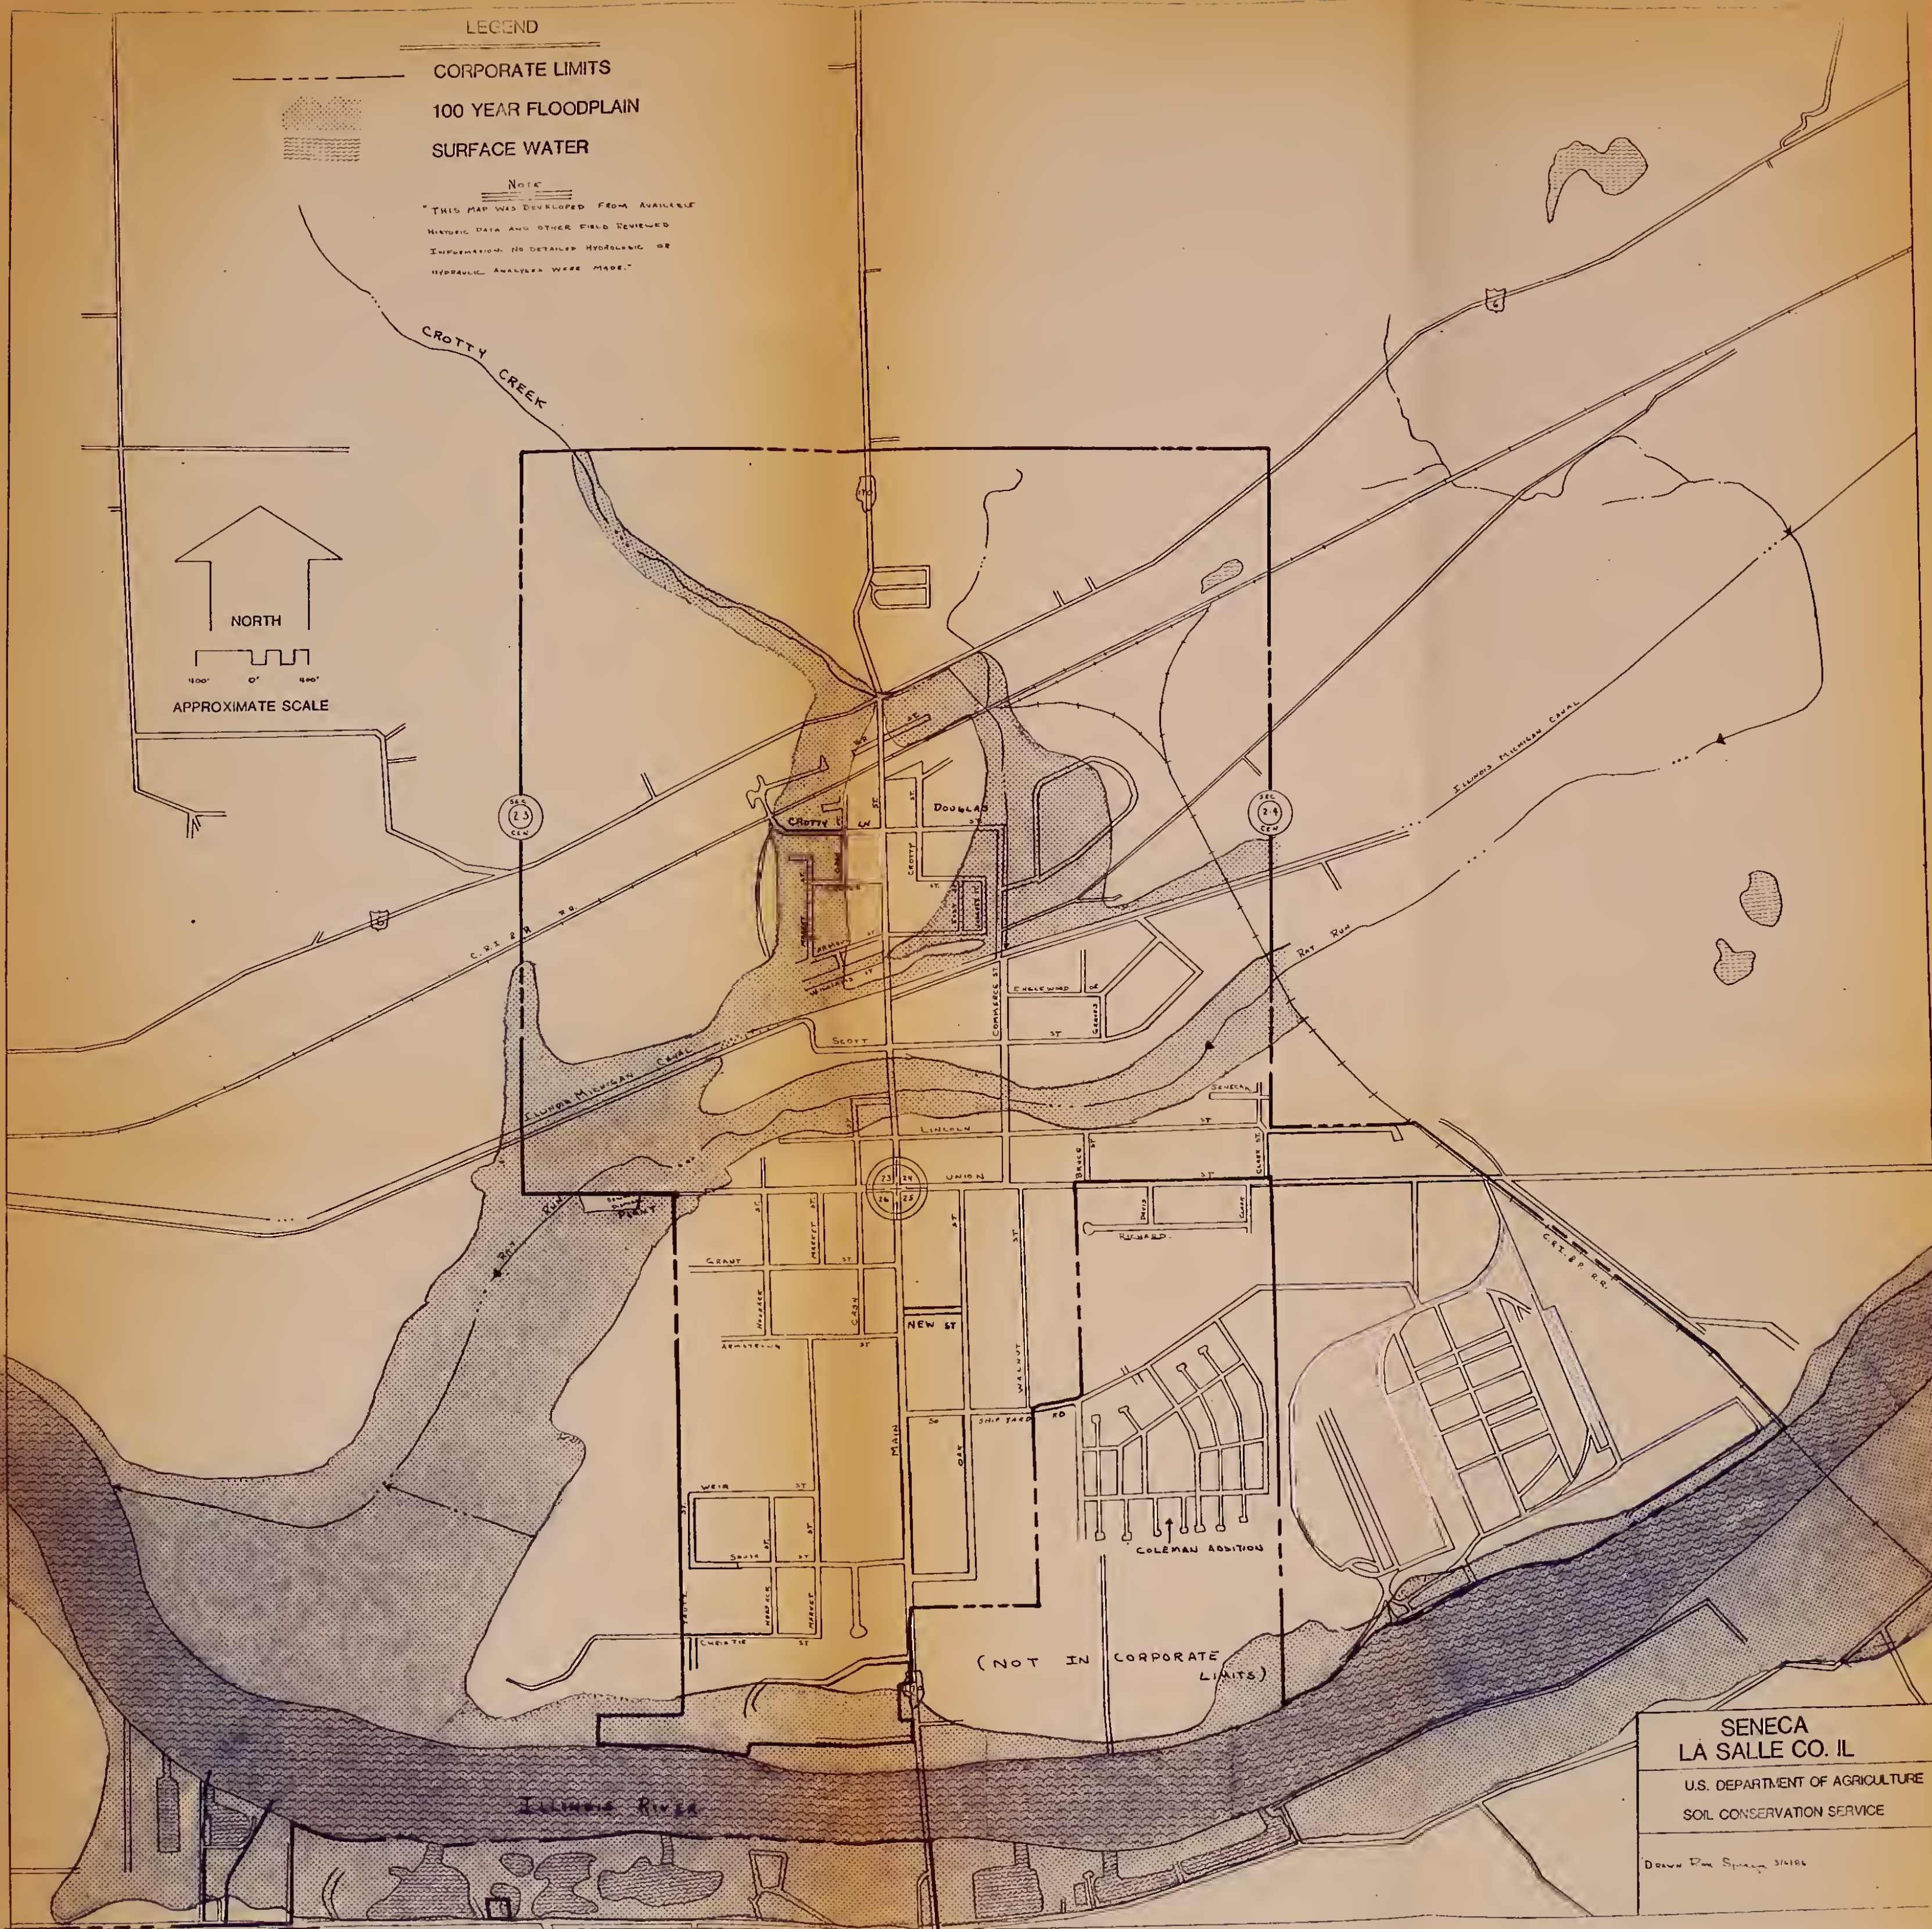
SENECA  
LA SALLE CO. IL

"THIS MAP WAS DEVELOPED FROM AVAILABLE  
HISTORIC DATA AND OTHER FIELD REVIEWED  
INFORMATION. NO DETAILED HYDROLOGIC OR  
HYDRAULIC ANALYSES WERE MADE."

Limited calculations of channel, culverts, and peak discharges were made as a part of this study. The inventory of flooding and water problems is based on a field review and interviews with local citizens. Interviews with local citizens were used to determine the 100-year floodplain. The 1985 Flood Insurance Rate Map for Seneca, along with interviews with local citizens, was used to determine the 100-year floodplain. Aerial photographs were provided by DWR. Damages were based on property value estimates during the field review, and the application of damage factors. These factors came from previous detailed floodplain management studies.
